Portage Creek Sediment Remediation Project Kalamazoo, Michigan

Pre-Sediment Removal Structure Feature Assessment
Removal Areas SA3-A, SA3-B and SA3-Access

**FLEIS & VANDENBRINK
ENGINEERING, INC.**

August, 2012

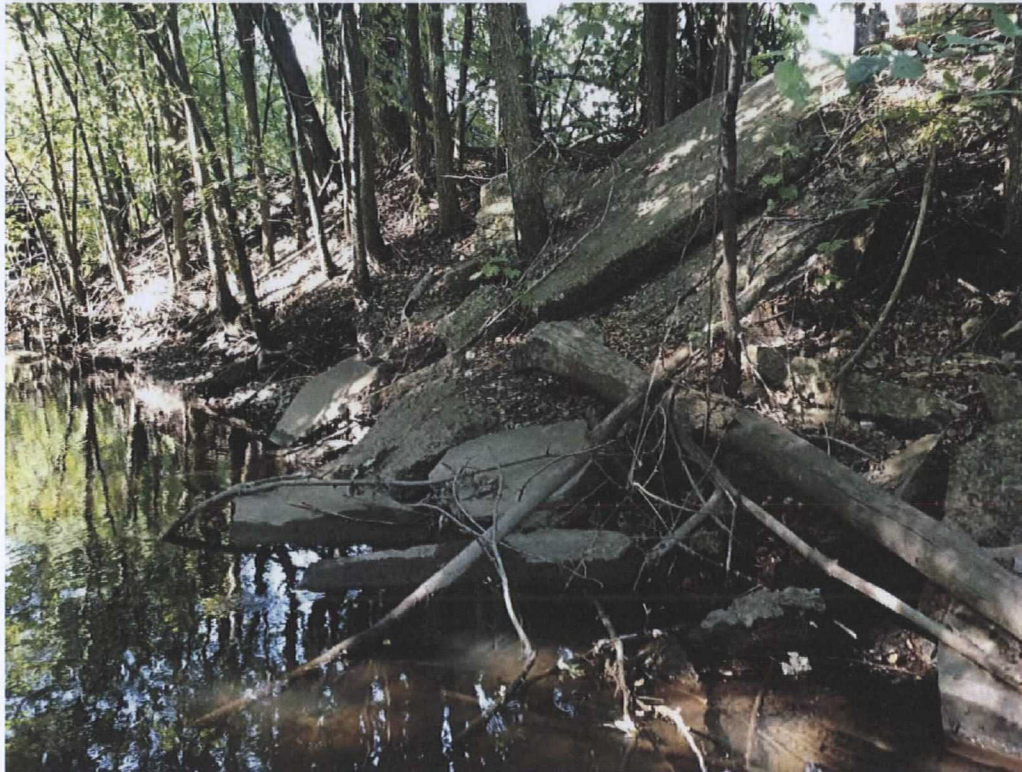
View of the structure from the north channel

- The slabs should be removed and replaced as required to facilitate sediment removal.

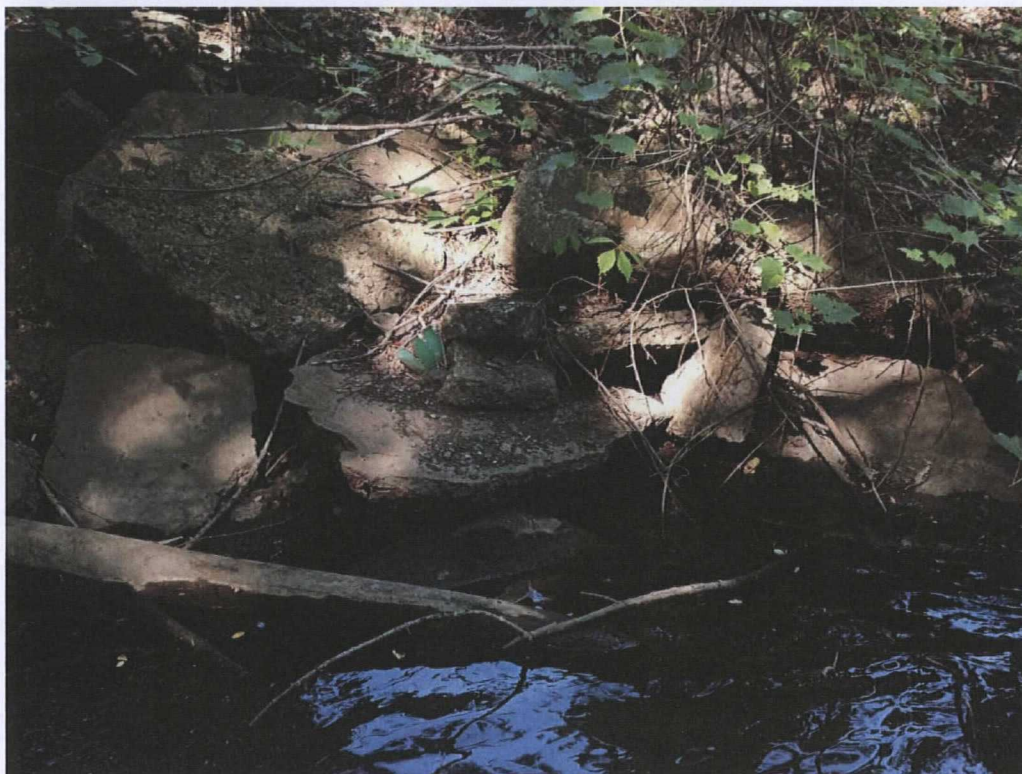
Settlement of slabs into the channel

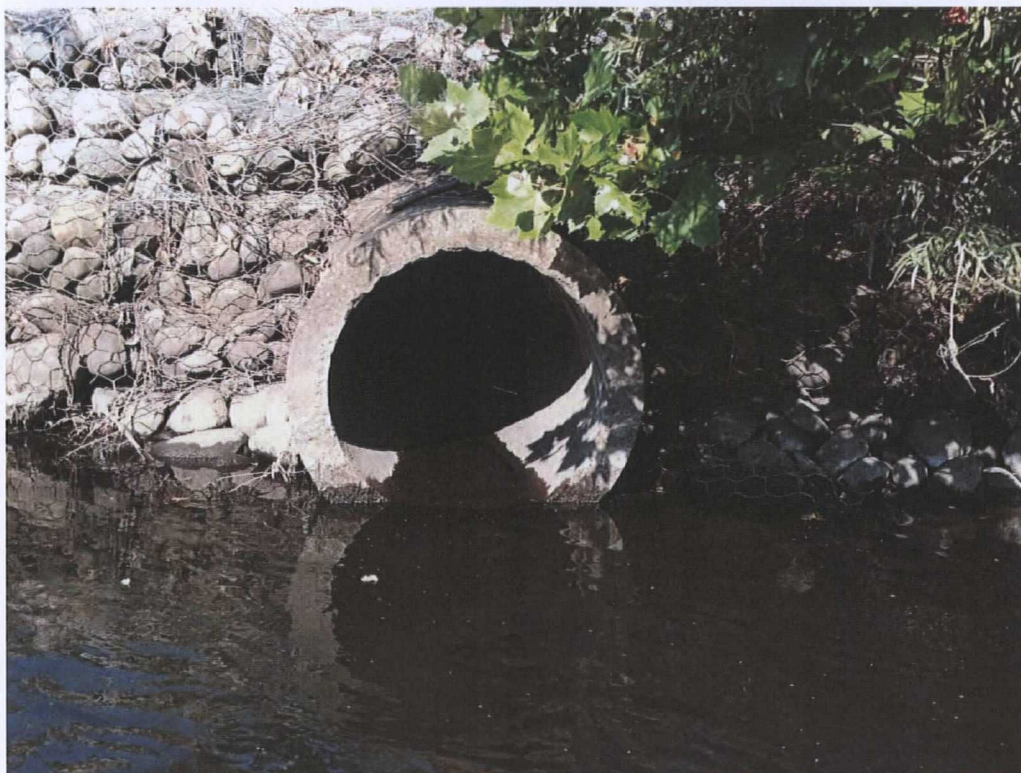
Stone loss in baskets along the waterline

- If a cofferdam is required for dewatering, it should be installed with a minimum 2' clearance to the outlet to avoid adversely impacting it. It will be difficult to install a sheet pile cofferdam against the gabion baskets without damaging them. Therefore sand bags are recommended either against the baskets or for the entire cofferdam.

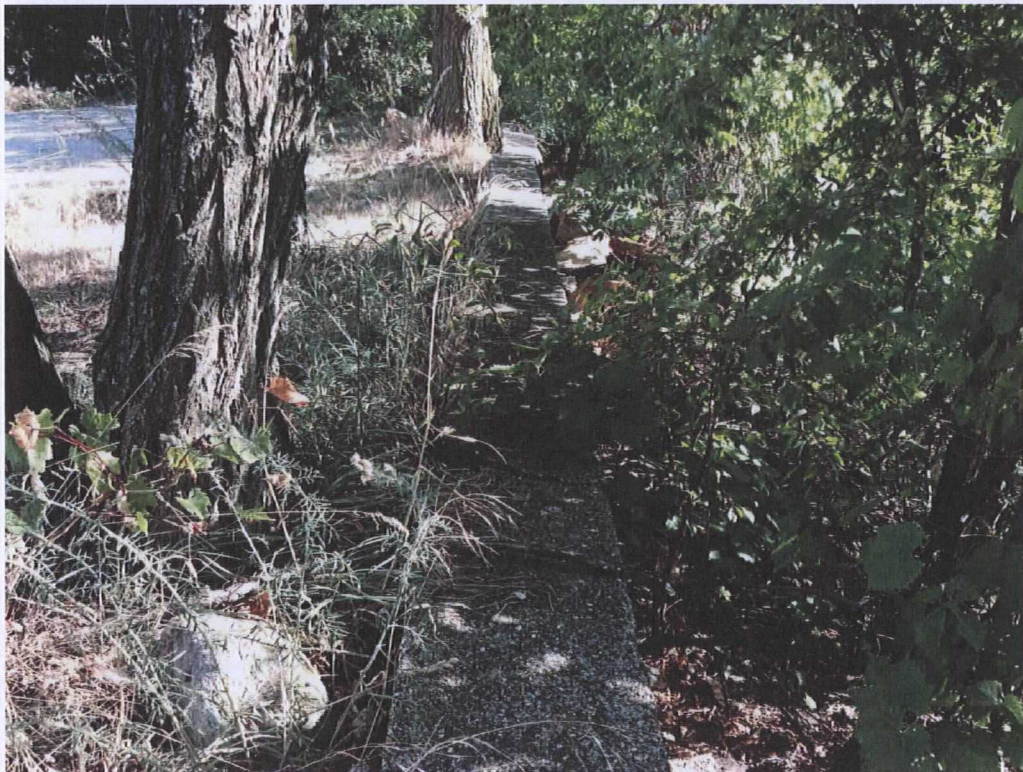
View of the retaining wall from the south

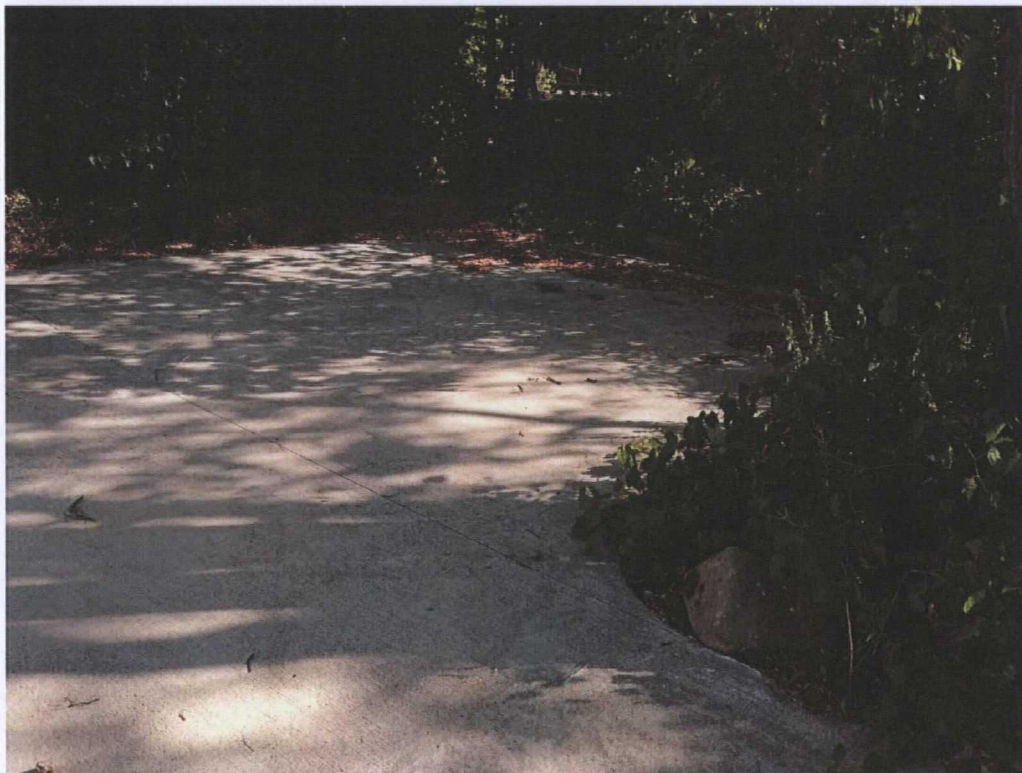
View of parking lot along top of bank

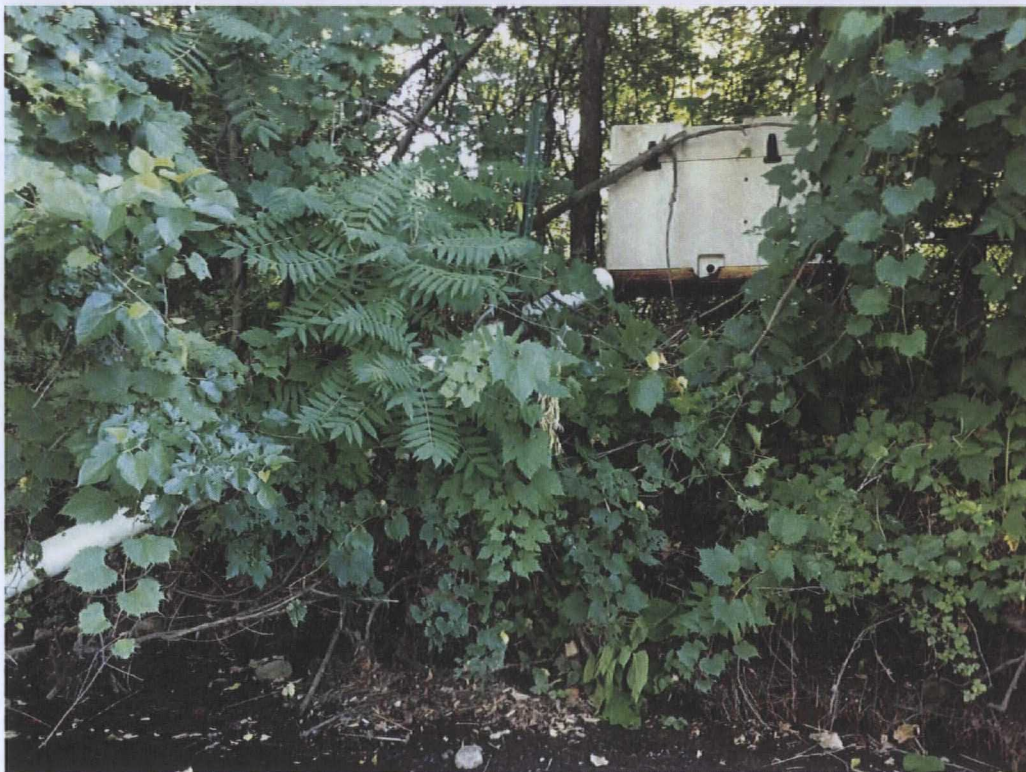
View of structure from channel

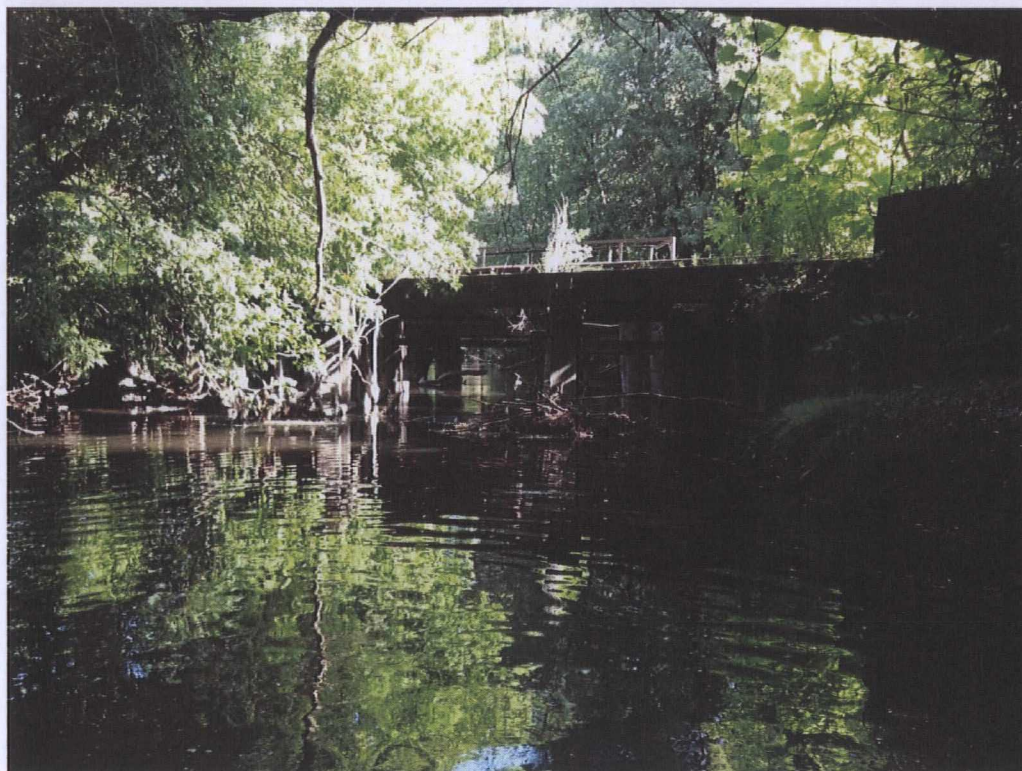
Elevation view of structure

- If a cofferdam is required for dewatering operations, it should be located south of the 42" outlet with a minimum clearance of 4'.
- Because the structures are supported on deep foundations (timber piles), they are less susceptible to vibration and settlement as structures on shallow foundations.

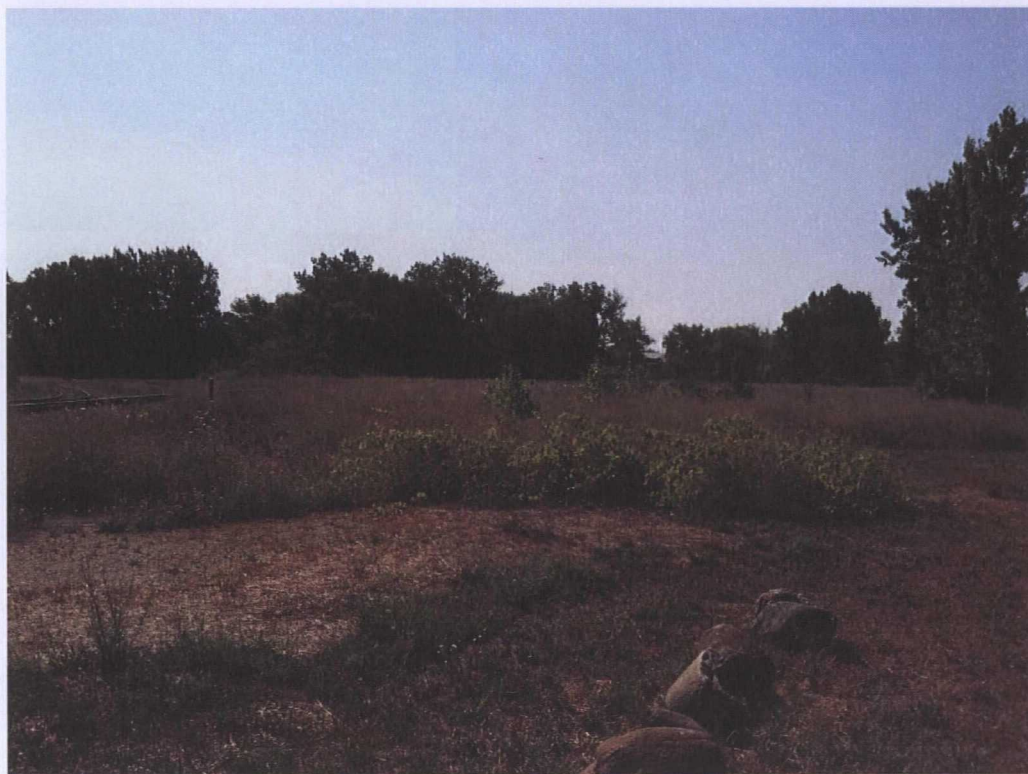
View of area looking south

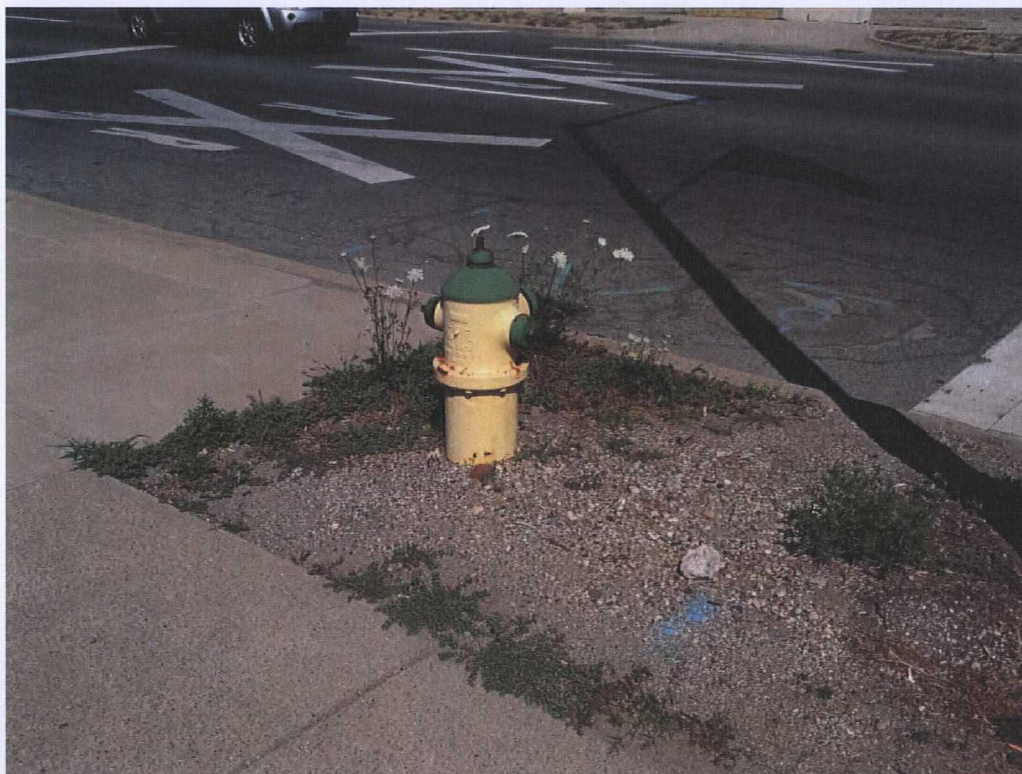
- The fire hydrant is in fair condition, with paint flaking and minor surface corrosion.

View of hydrant looking north toward East Michigan Avenue

- The hydrant should be identified/protected with construction fencing or similar during the work.

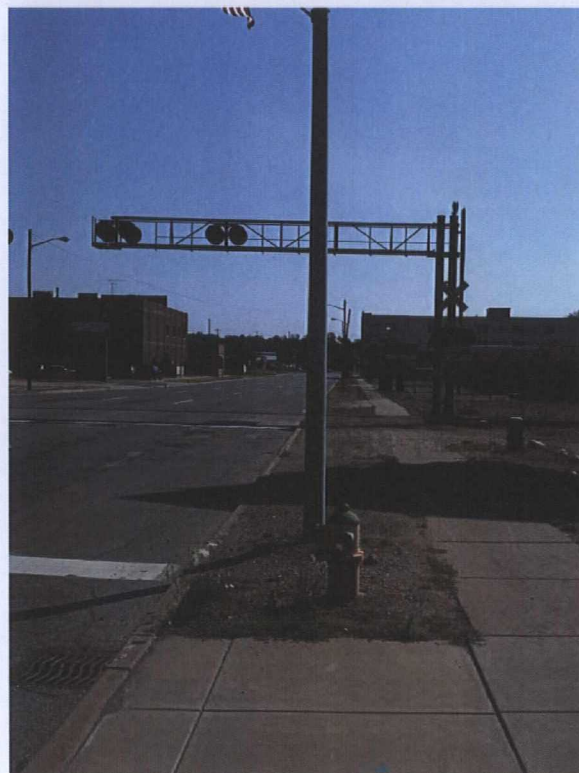
View of pole looking east showing relation to hydrant and east railroad tracks

- The pole should be identified/protected with construction fencing or similar during the work.

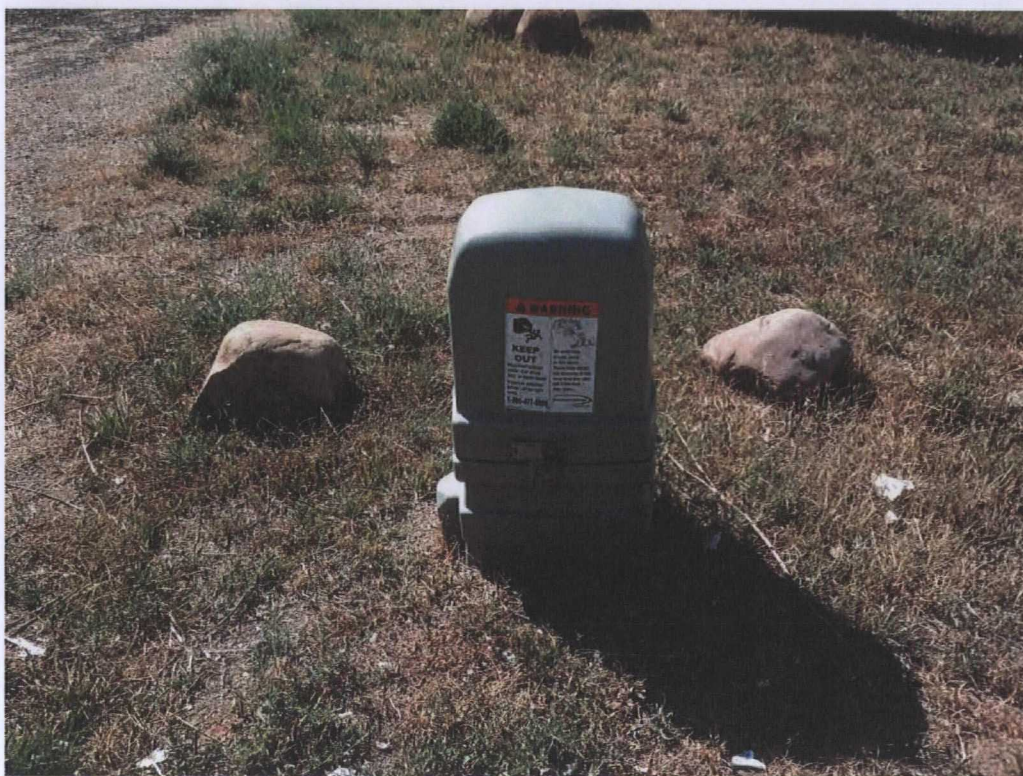
View of the pedestal looking south

- The pedestal should be identified/protected with construction fencing or similar during the work.

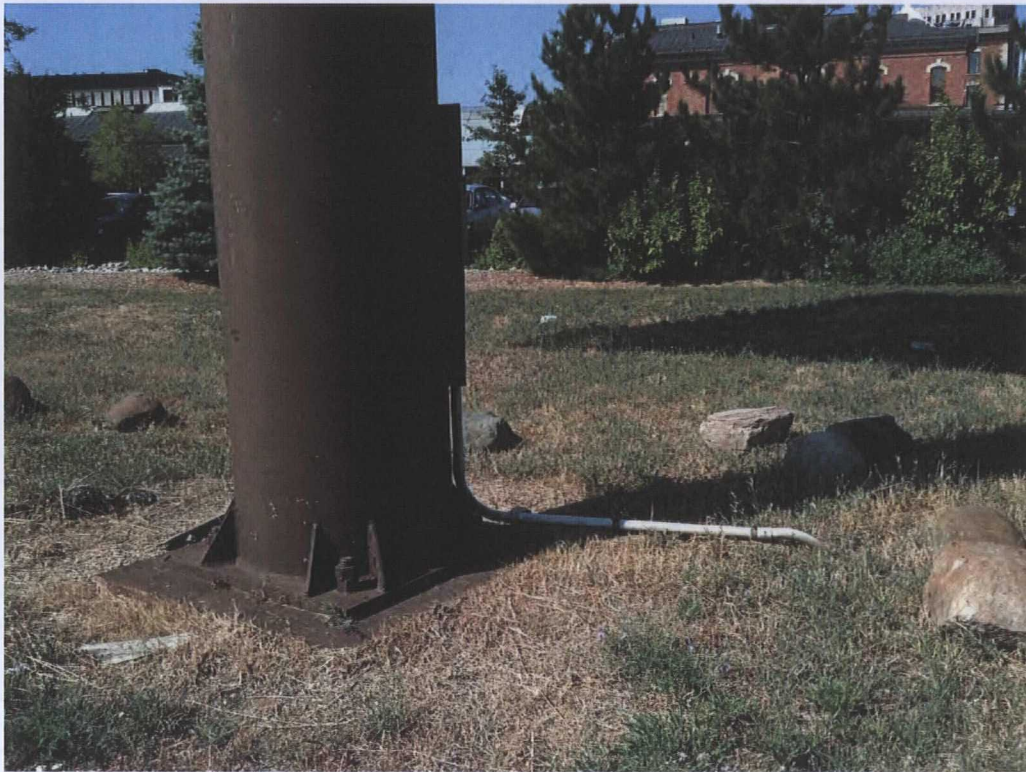
View of billboard foundation looking southwest
